The Acushnet River Restoration Project: A test pilot case study for future restoration projects in Massachusetts

John J. Sheppard

Massachusetts Division of Marine Fisheries

1. The Study Area: The Acushnet River

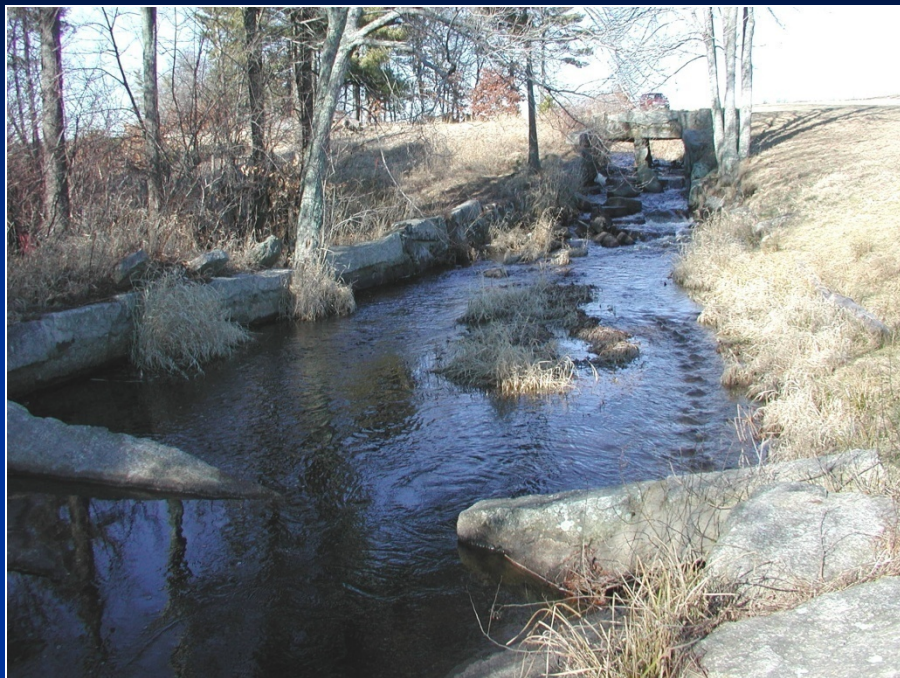
Lower Section

River Mile: 8.1

Dam Type: Dam & elevation change

Material: Granite with wooden boards

Impoundment: 220 acres

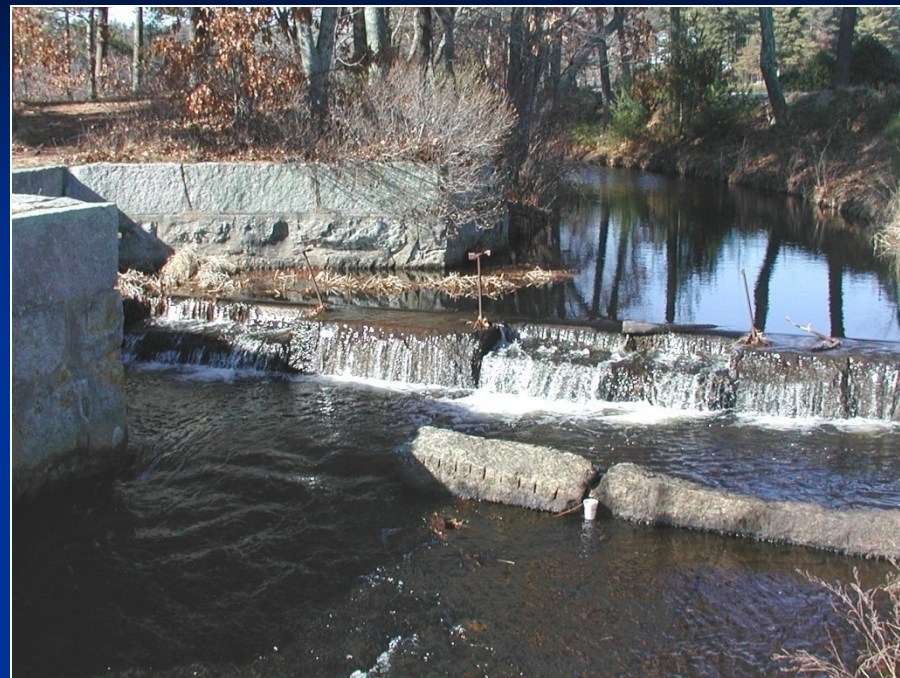
Upper Section

Year Built: 1867

Owner: City of New Bedford

Spillway Width: 50 feet

Spillway Height: 11 feet

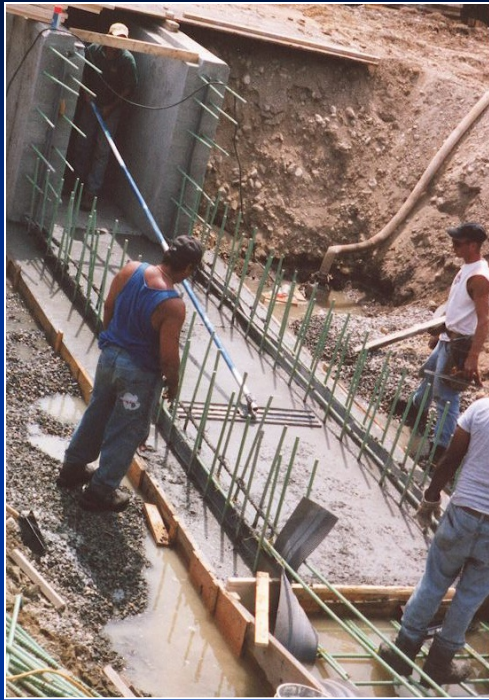
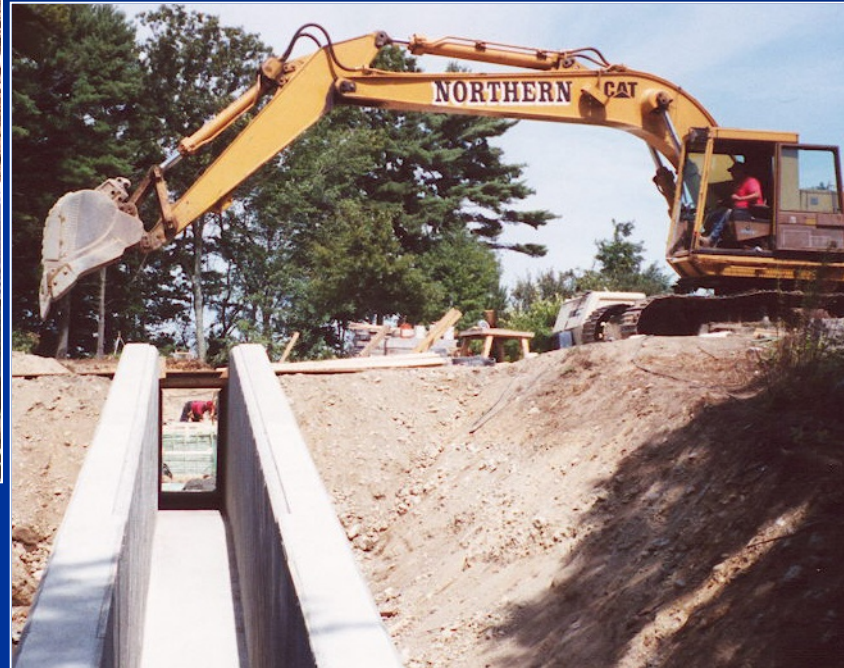
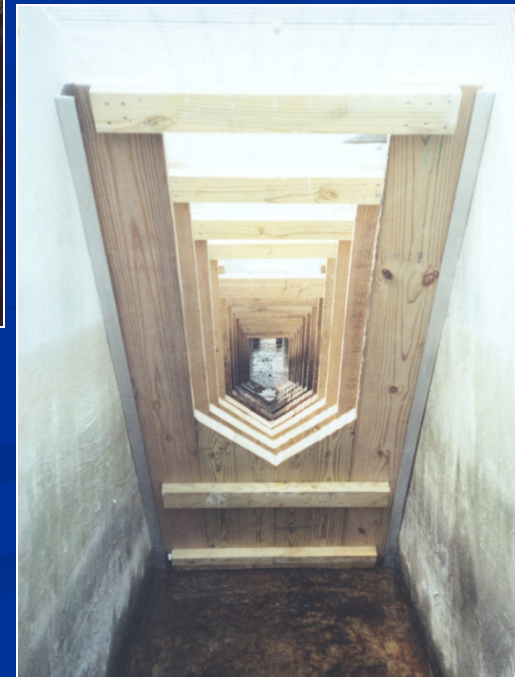
**2002: State-of-the-art denil fishway
constructed**

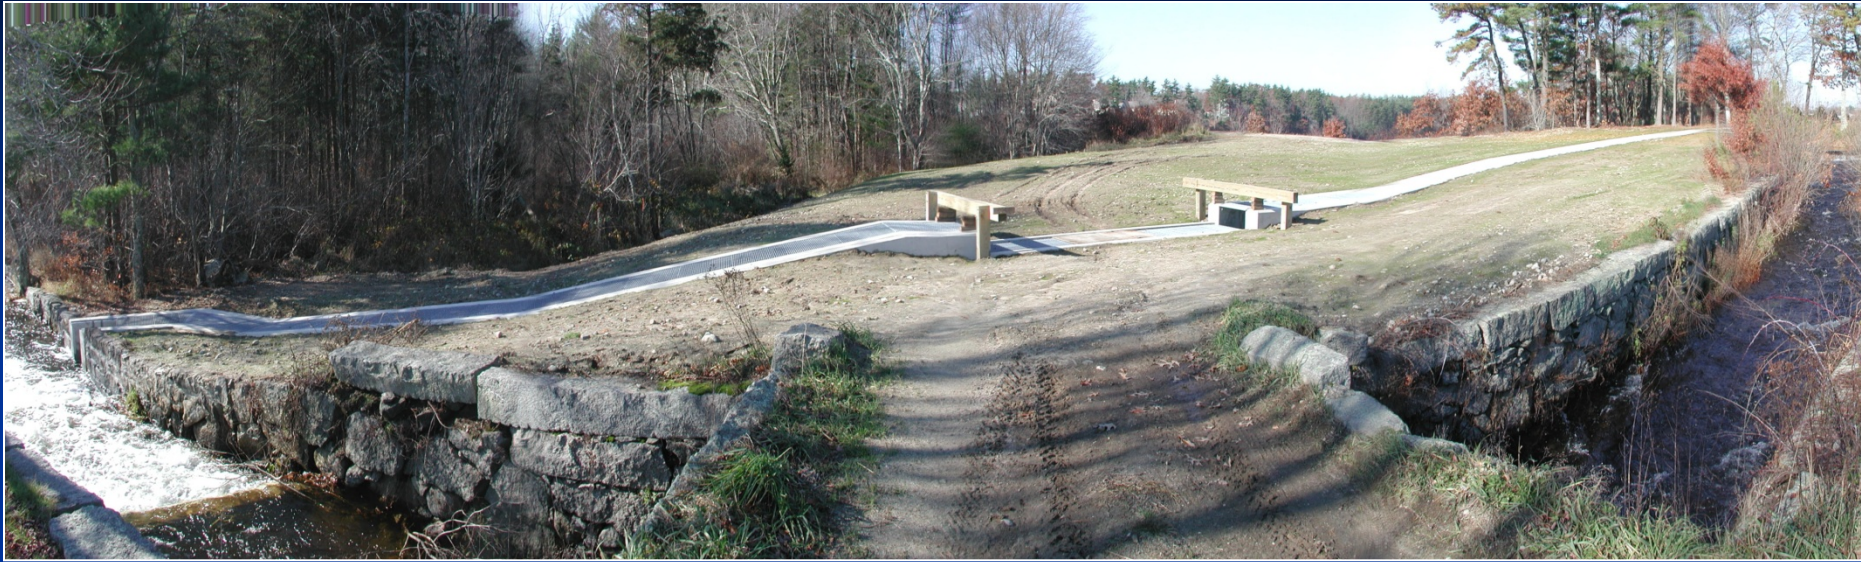
Fishway Design: Denil

Material: Concrete with wooden baffles

Length: 264 feet

Inside width: 3 feet

Outside width: 5 feet

No. baffles: 26

Notch width: 21 inches

Functionality: Passable ($\approx 12 - 14$ cfs)

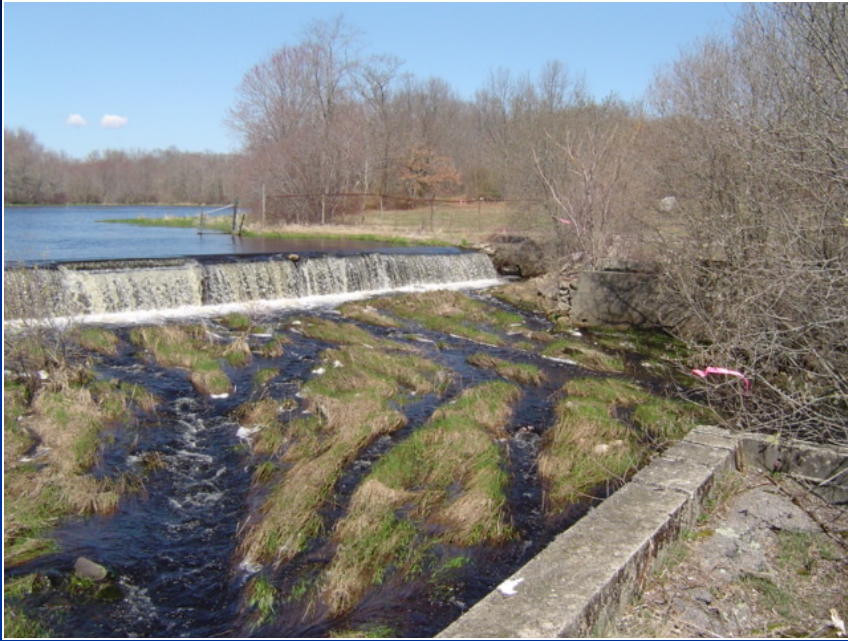
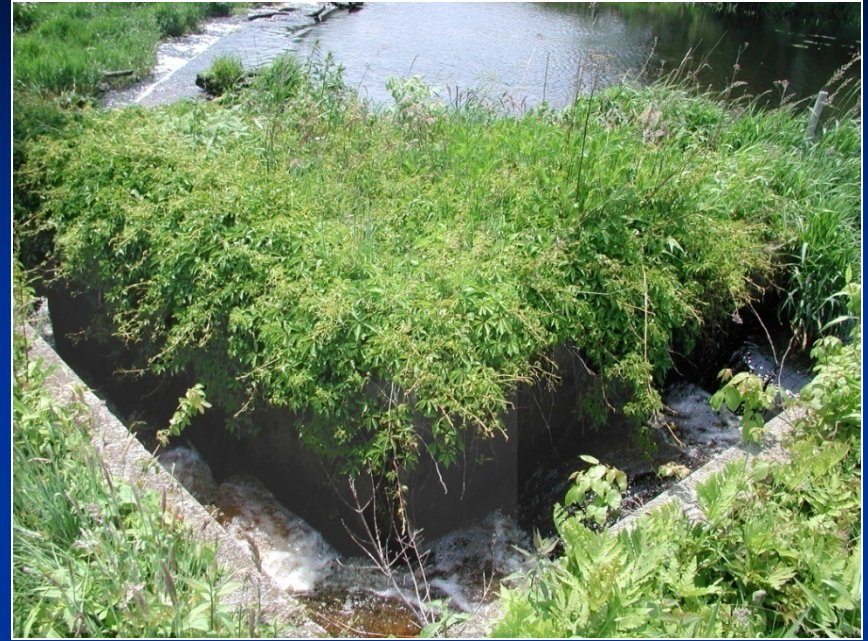
River Mile: 4.4

Type: Dam

Material: Concrete & stone

Impoundment: Saw Mill Pond (9.5 acres)

Year Built: 1746 (rebuilt in 1920)

Spillway Width: 118 feet

Spillway Height: 4.6 feet

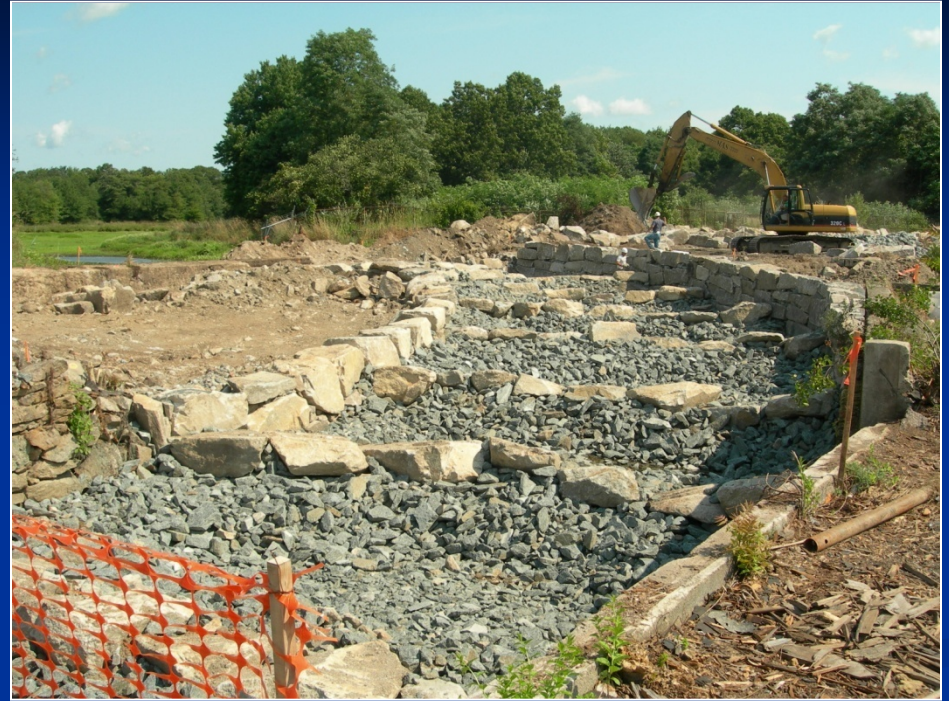
Sawmill Dam fishway construction: July, 2007

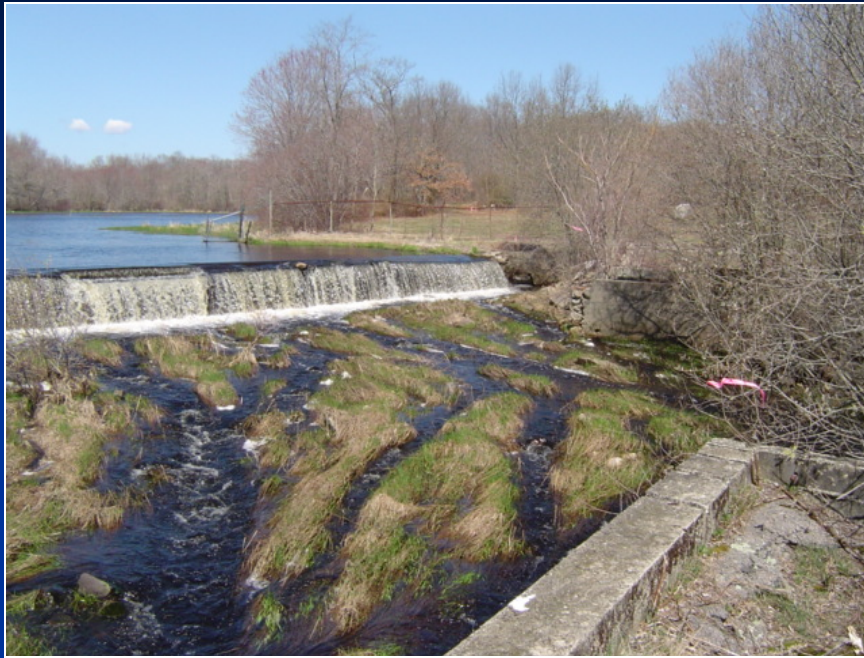
Pre-Construction

Acushnet Sawmill Fishway (Autumn, 2005)

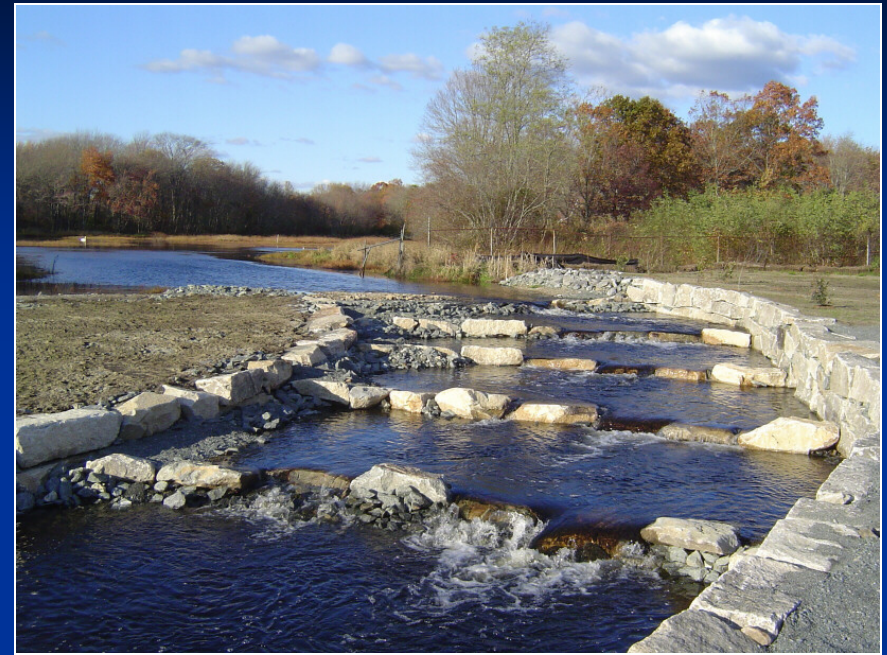
Post-Construction

Acushnet Sawmill Fishway (Autumn, 2007)

A relatively new innovation which effectively eliminates dams without removal.

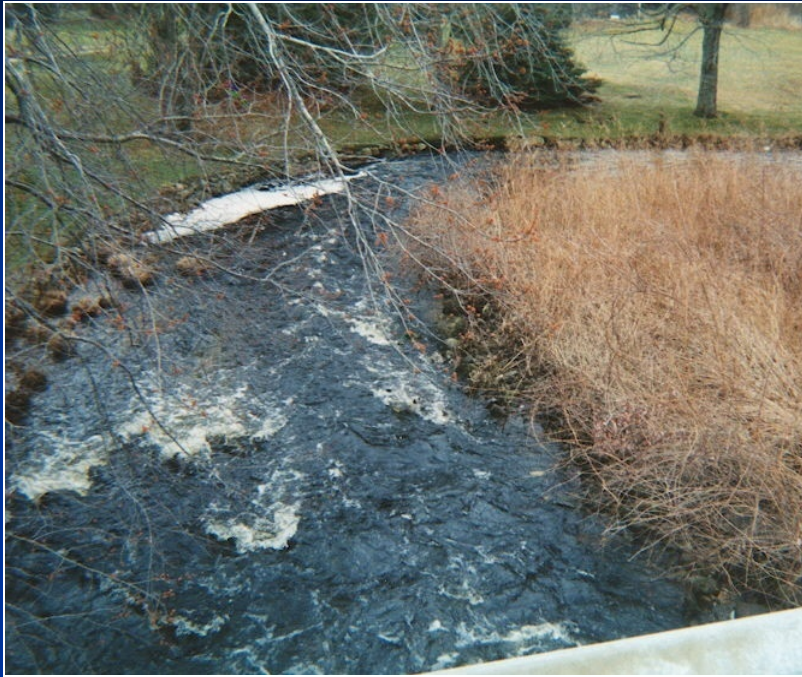
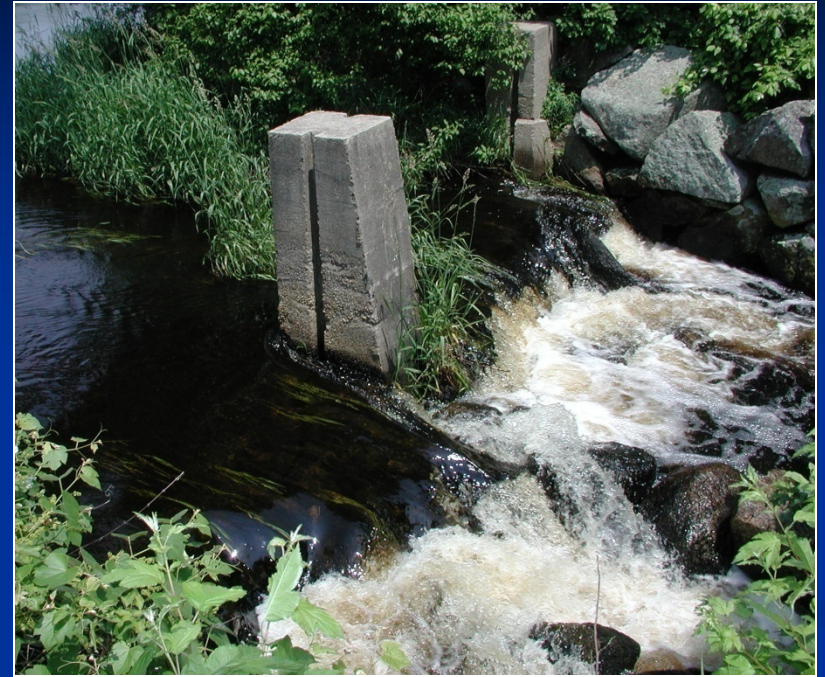
River Mile: 5.3

Type: Dam

Material: Concrete with wooden boards

Impoundment: 12.5 acres

Year Built: 1920

Spillway width: 4.7 feet

Spillway Height: 1.7 feet

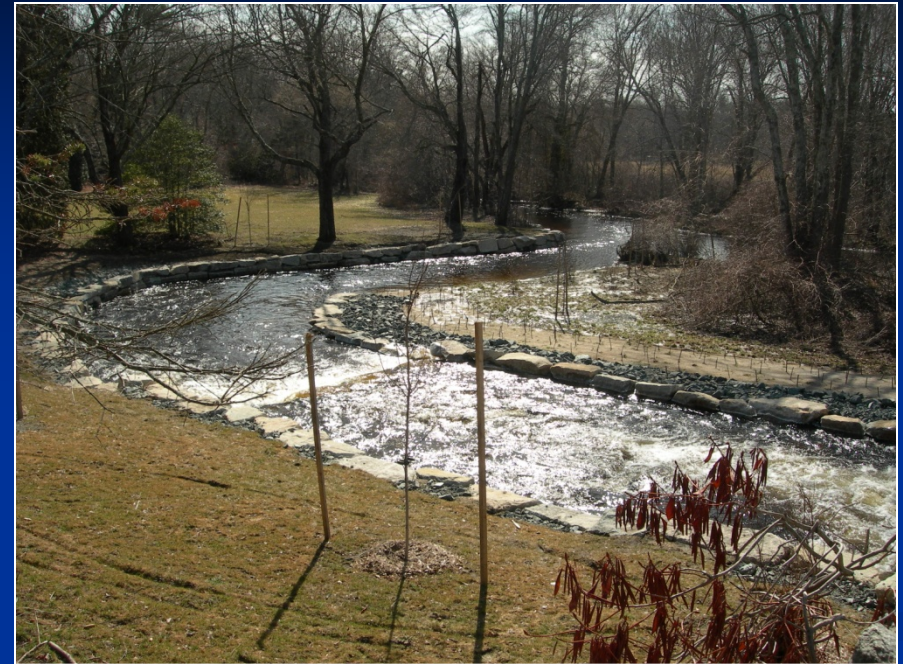
Hamlin Street Fishway

(May, 2008)

Similar structure built at Hamlin Street to overcome smaller elevation differential (5 rock weirs, 4 pools)

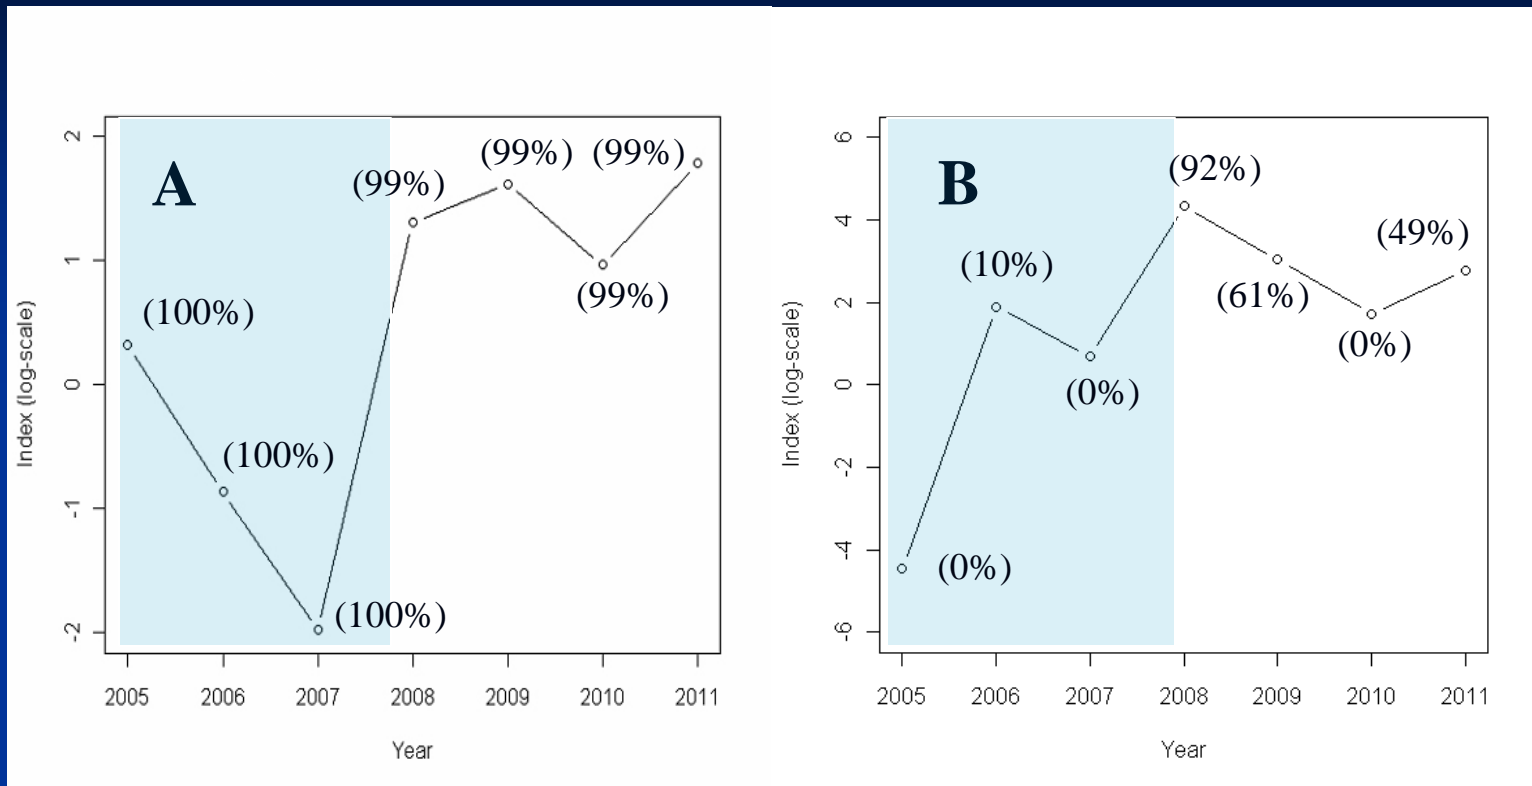
A. Sawmill ($F = 11.7, p < 0.01, df = 6$)

B. Reservoir ($F = 23.1, p < 0.01, df = 6$)
By period ($F = 2.0, p < 0.2, df = 1$)

1. Analysis of Deviance showed that year is a significant factor, indicating differences in CPUE among years
2. Increased catch rates at the Sawmill station during post-constriction. YOY comprised 99% of the catch and migrations occurred over longer temporal scales.
3. Increased catch rates at the Reservoir station. Catch rates grouped by monitoring period (pre v. post). Variability in catch rates too great to detect differences. Higher proportions of YOY were observed post-construction.

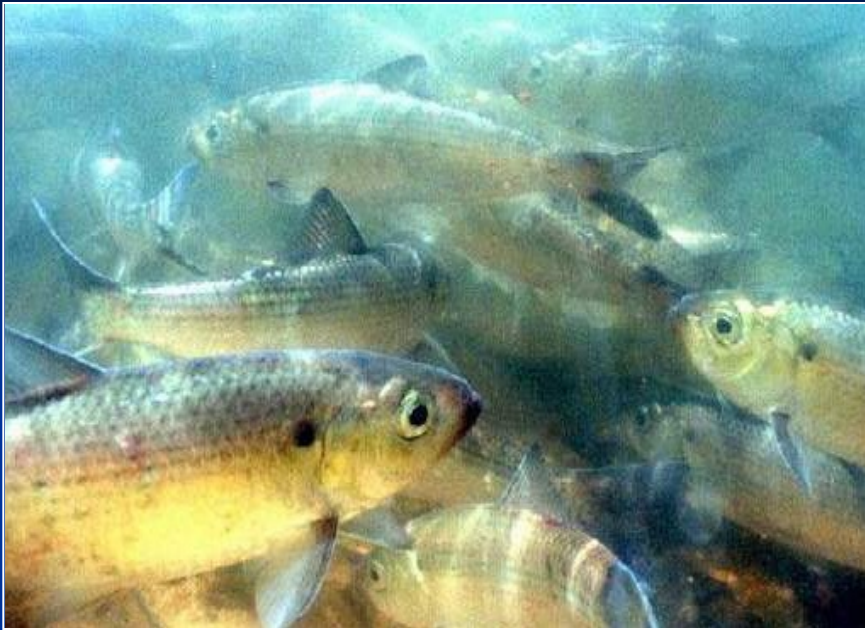
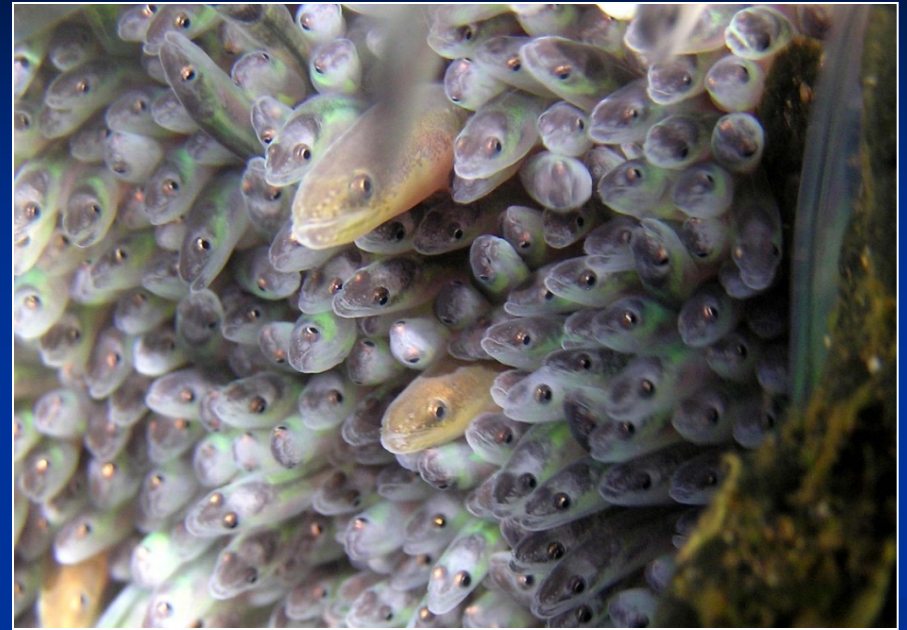
Biological Monitoring (cont.): Summary Observations

1. Results suggest new fishways have resulted in improved access to spawning and nursery habitat (New Bedford Reservoir) for river herring
2. Increased recruitment of elvers into the watershed during the post-construction period
3. In particular, YOY elvers have access to the upper watershed (increased numbers present in samples)
