Coonamessett River Trust

COONAMESSETT RIVER RESTORATION PROJECT

Lower Coonamessett River Restoration Project Area Barriers and Proposed Outcomes with NOAA Funds

Coonamessett River Restoration Project Falmouth, MA Phase 1: Pre- and Post-Construction

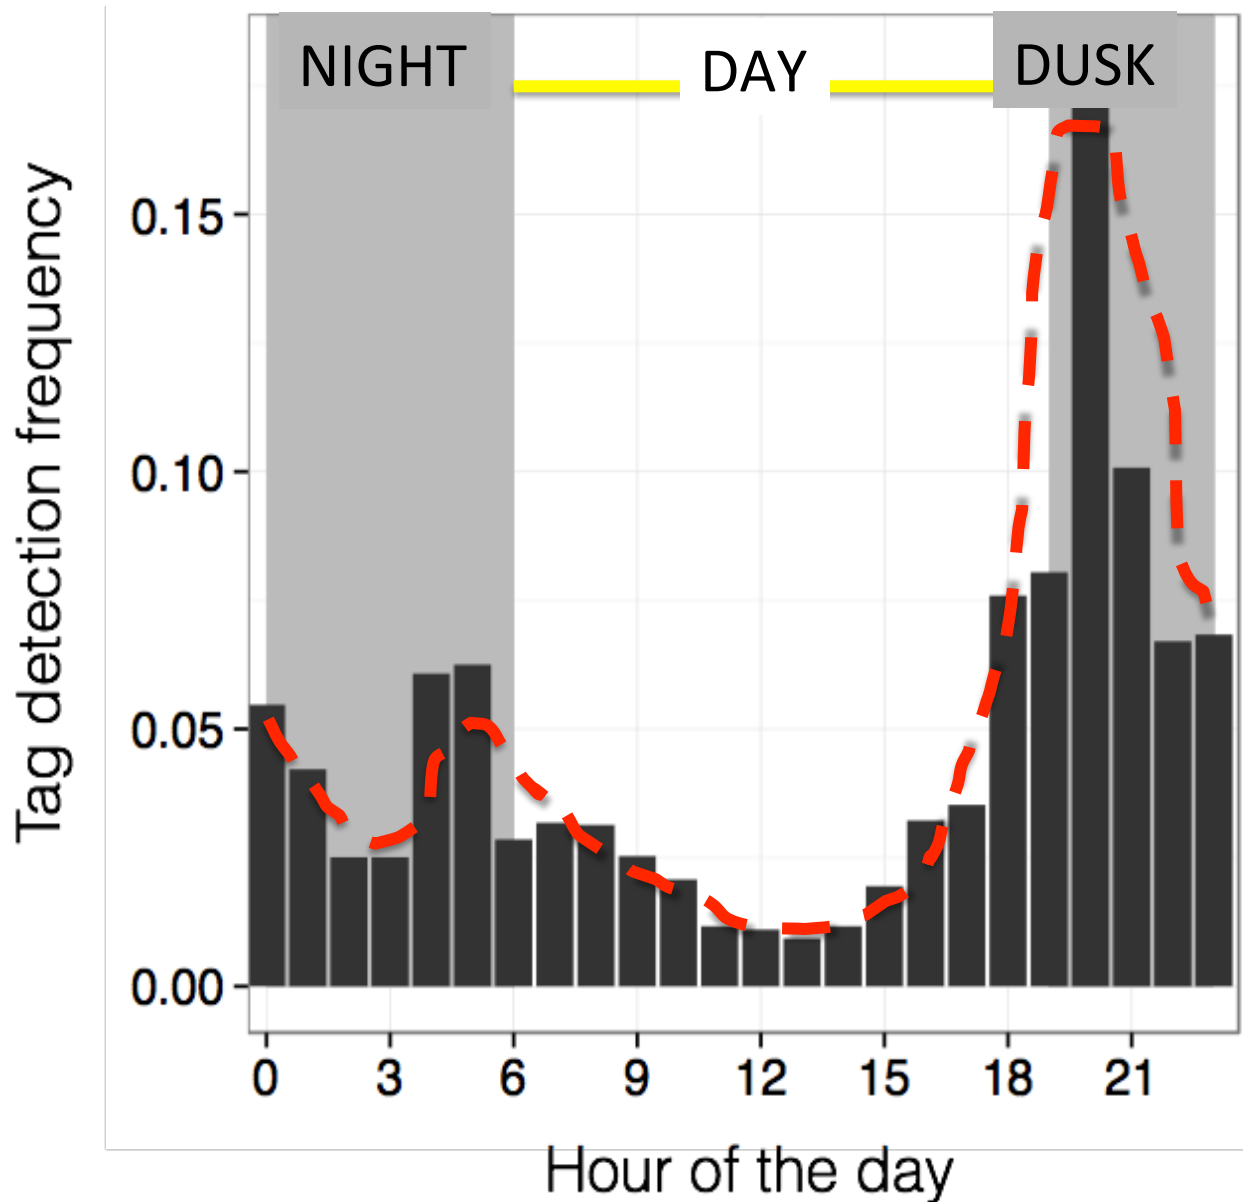
Night Time Migration

Perhaps without riparian cover or in-stream structure
high bird predation has driven the fish
to migrate at night?

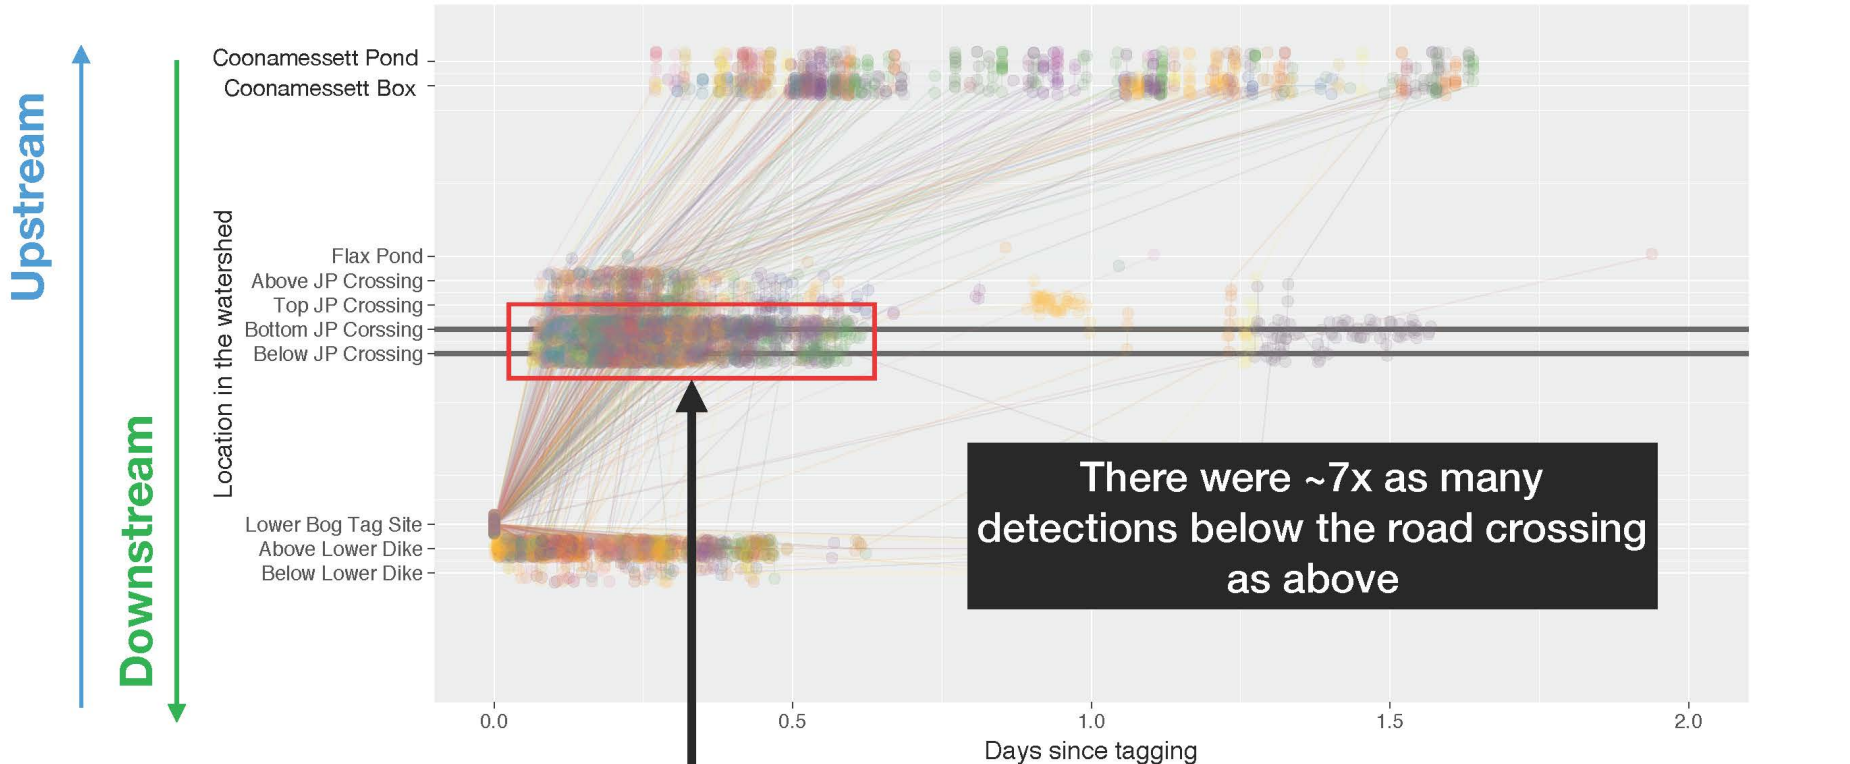
John Parker Rd. Crossing

Standardized movements of all fish tagged in 2017

There were ~7x as many detections below the road crossing as above

Dense set of points from many detections below the culverts

● = seen at antenna
— = movement between antennas

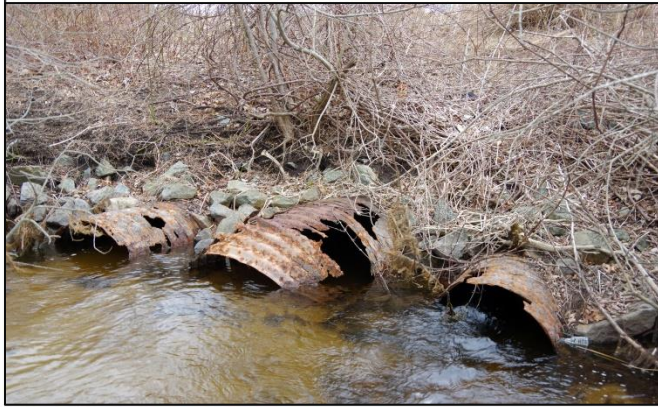
John Parker Road Culvert: design and permitting to replace with a bridge or similar

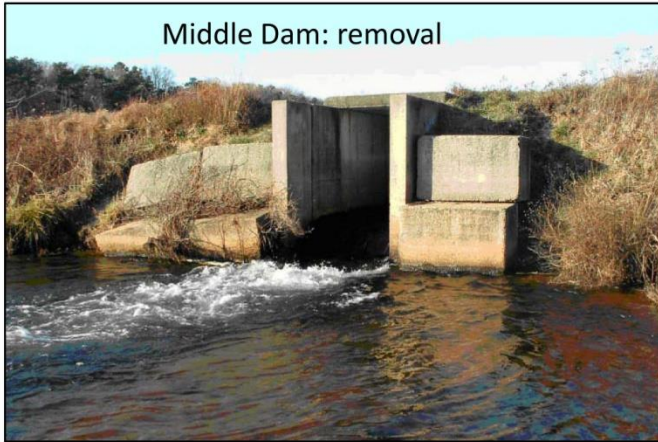
Middle Dam: removal

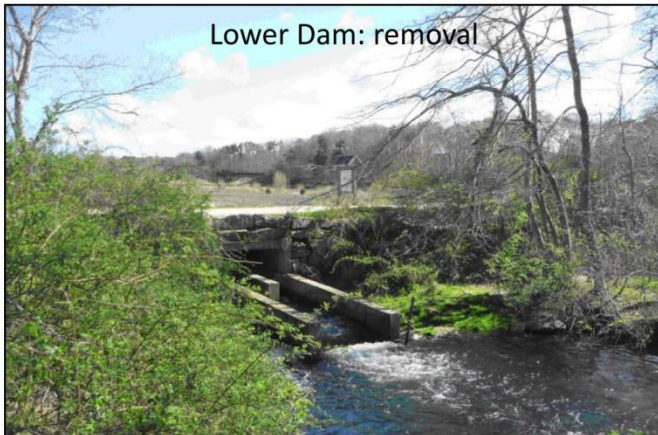
Lower Dam: removal

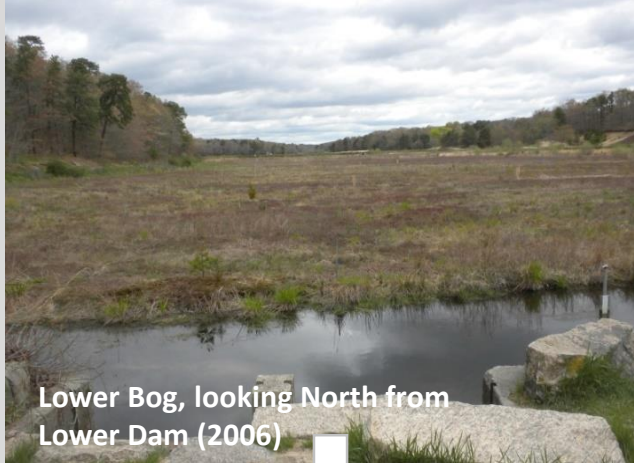
Lower Bog, looking North from Lower Dam (2006)

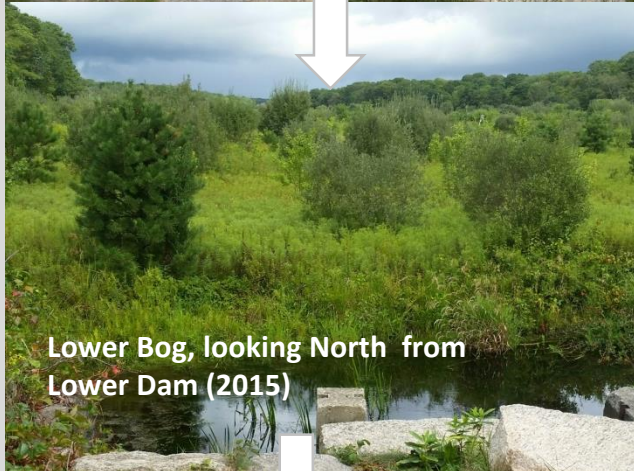
Lower Bog, looking North from Lower Dam (2015)

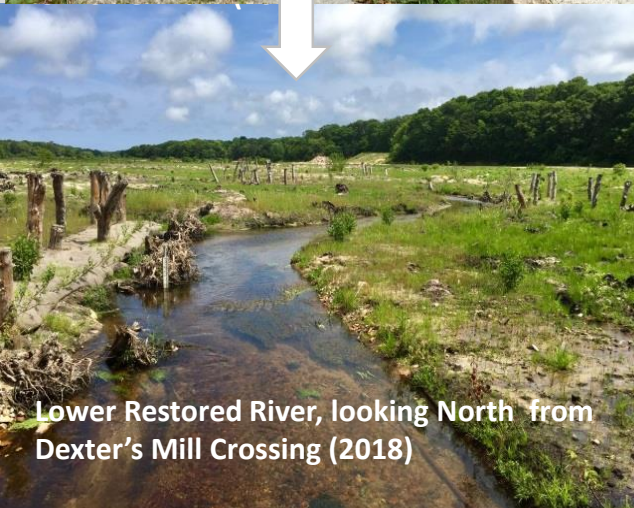
Lower Restored River, looking North from Dexter's Mill Crossing (2018)

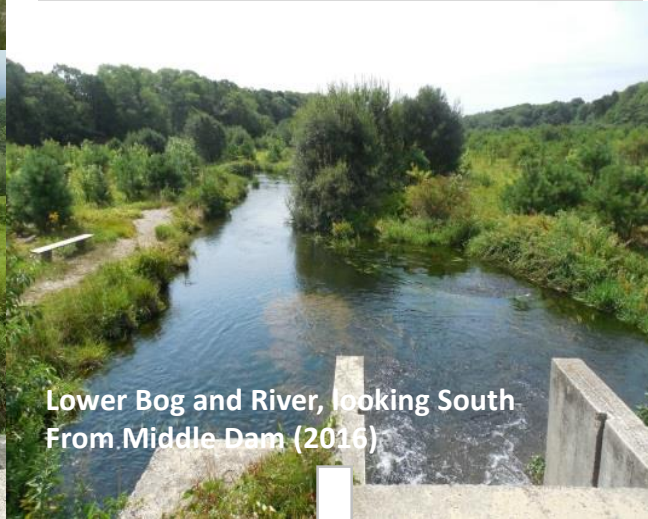
Lower Bog and River, looking South From Middle Dam (2016)

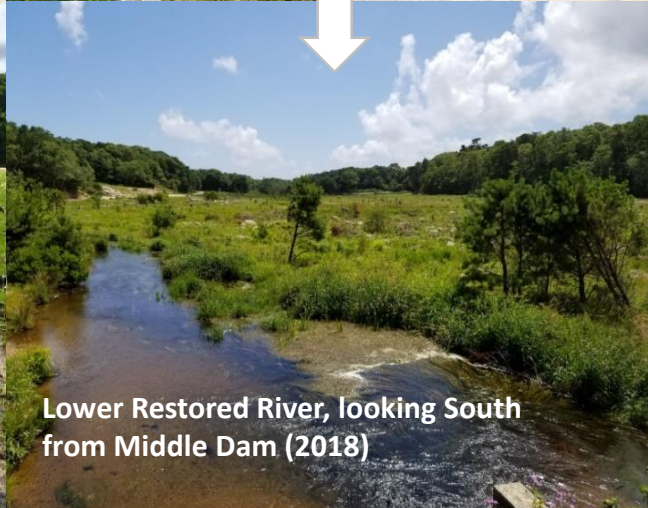
Lower Restored River, looking South from Middle Dam (2018)

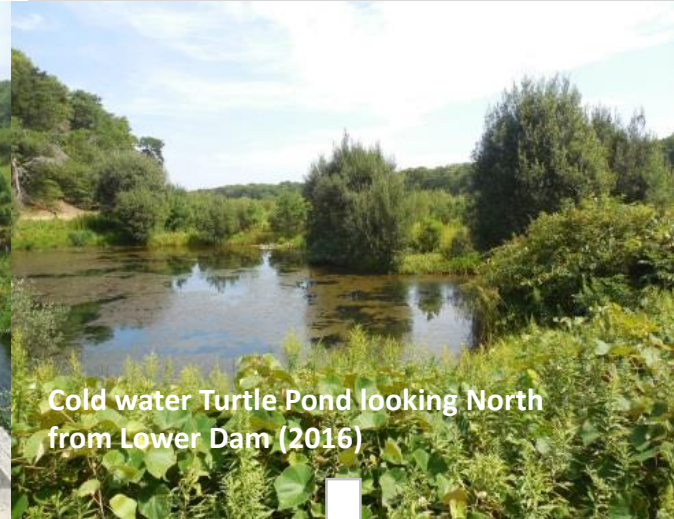
Cold water Turtle Pond looking North from Lower Dam (2016)

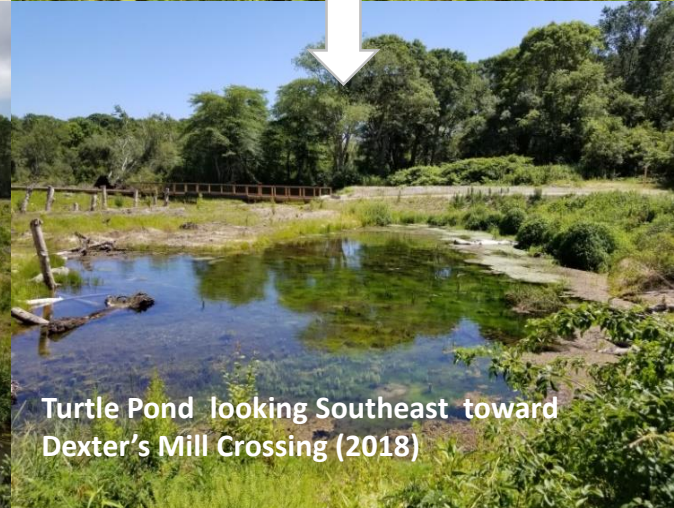
Turtle Pond looking Southeast toward Dexter's Mill Crossing (2018)
