River Herring Management Update: 2016

**River Herring Network, New Bedford,
October 27, 2016**

Massachusetts Division of Marine Fisheries

River Herring Management Update

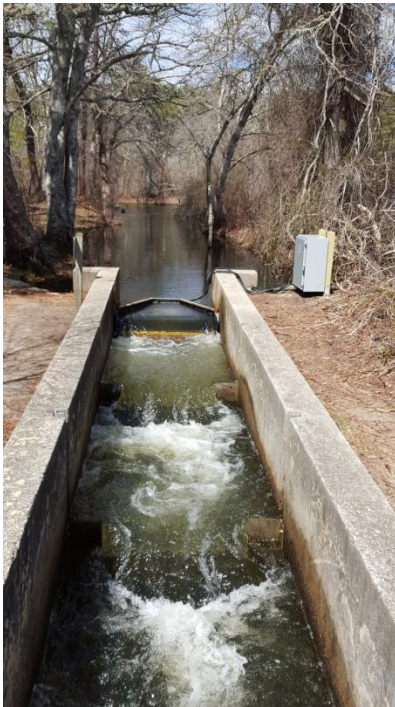
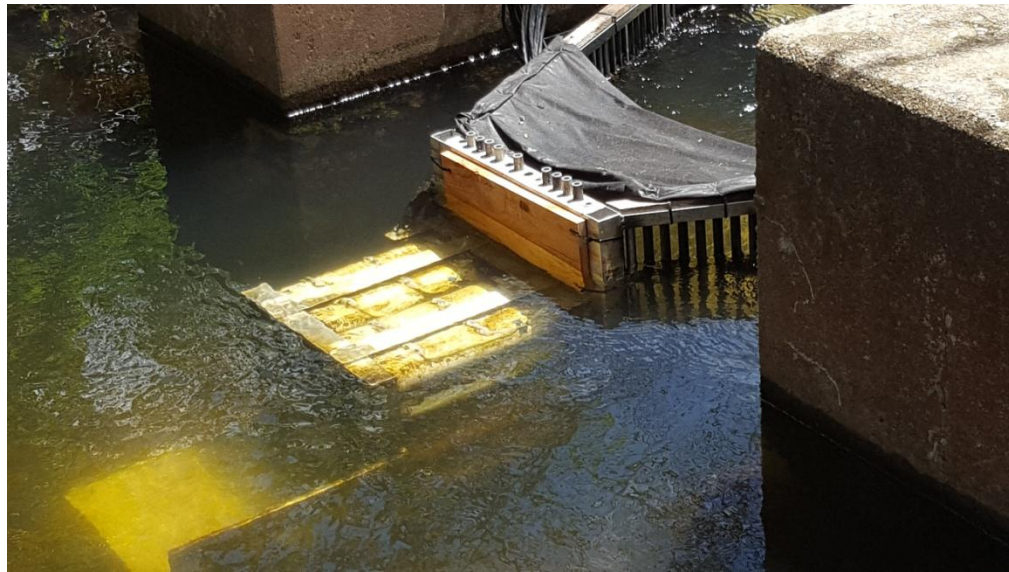
2016: New DMF electronic counter – Herring R., Harwich

2 new partner video stations – Ipswich R. (IRWA), Herring Creek (Martha's Vineyard – Aquinnah Tribe)

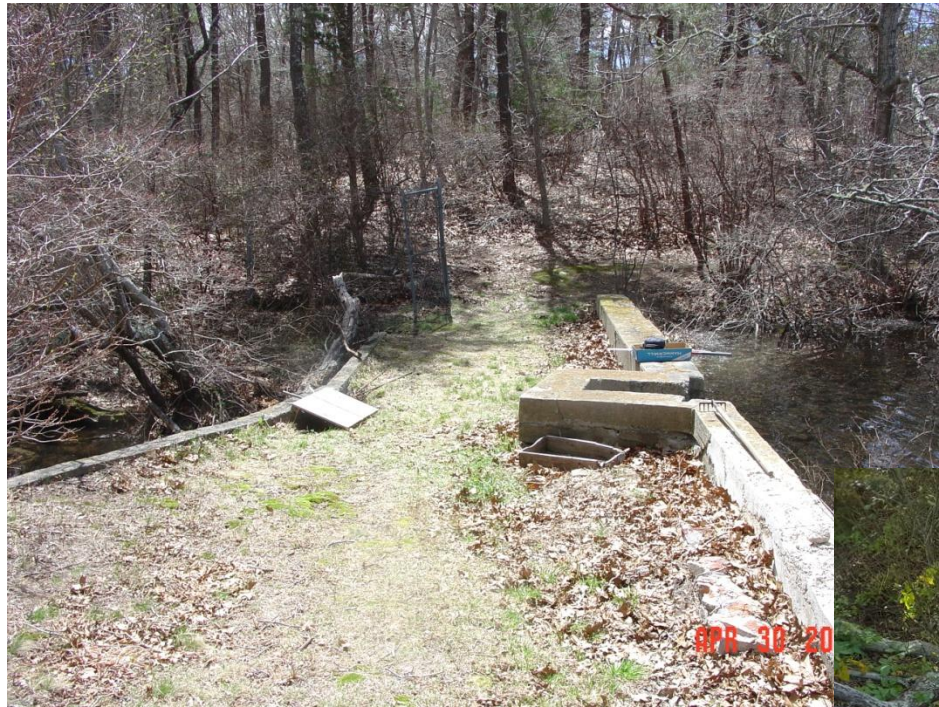
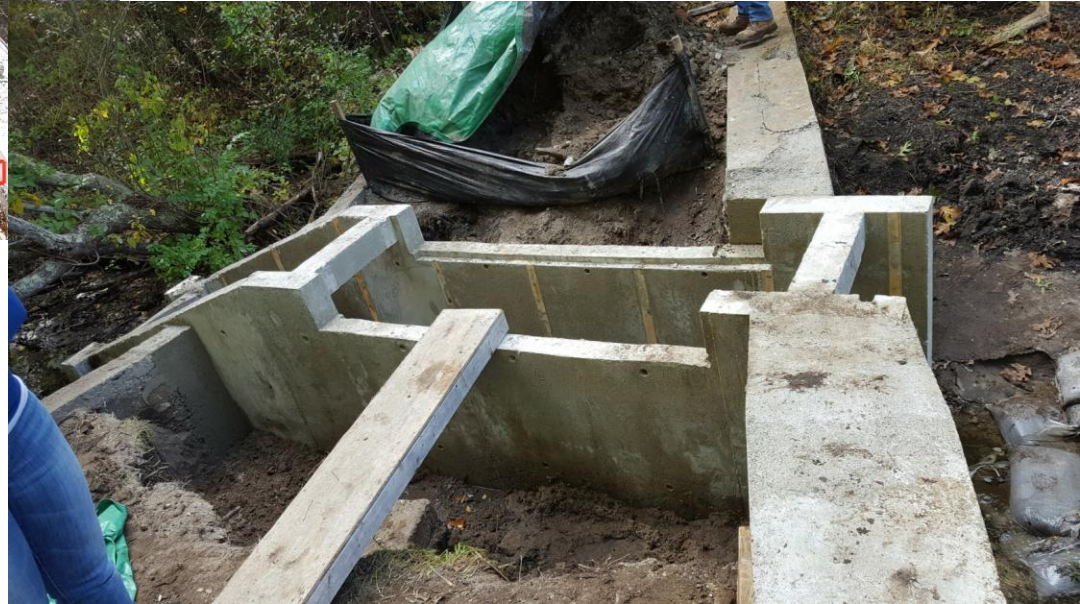
Bourne Pond, Falmouth: new concrete weir/pool fishway nearly completed.

Central Falls Dam, Aberjona River, Winchester: new steeppass fish ladder in concrete frame.

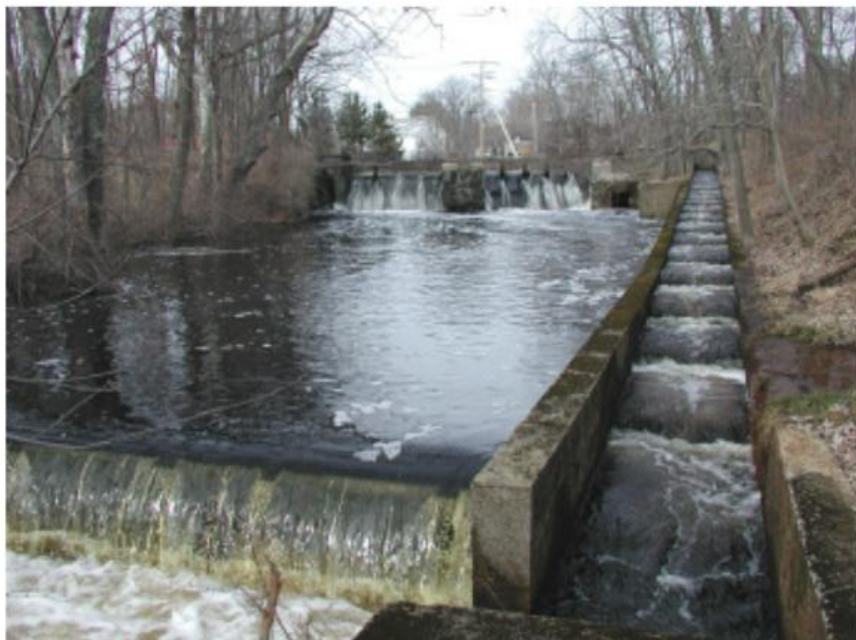
High Street Dam, Town River: public meeting Nov. 17th to launch dam removal feasibility study following owner signing a letter to approve this process

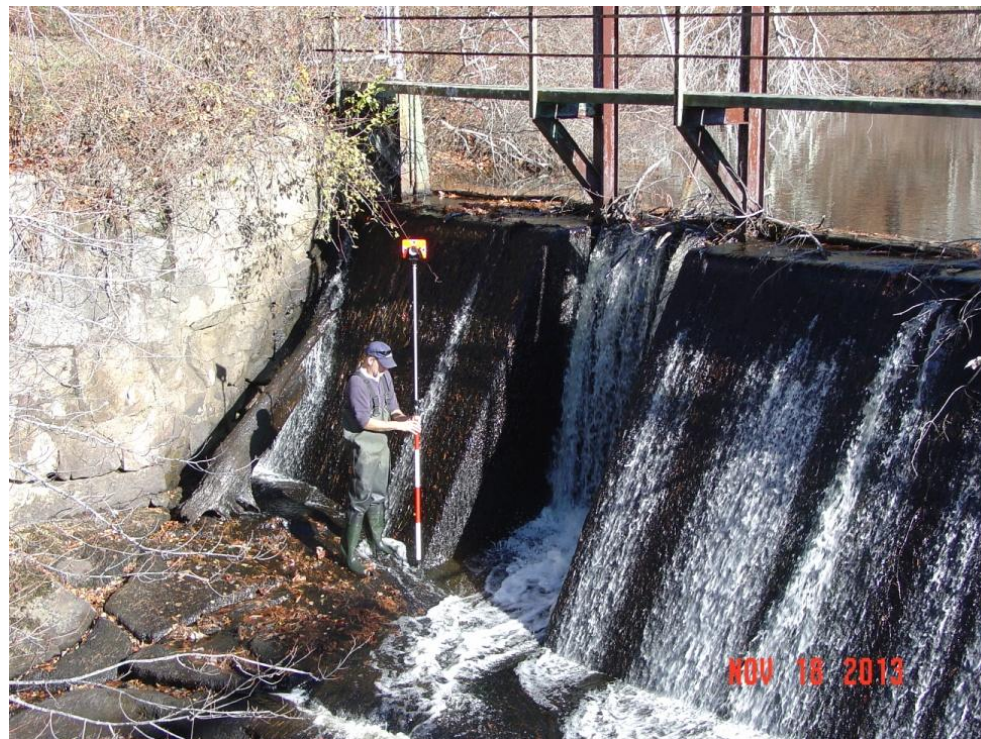
*Forge Pond Dam,
Westport River: Nov
meeting with owner to
discuss MOU on installing
a fish ladder*
