Massachusetts Division of Marine Fisheries Diadromous Fish Update

Brad Chase - MA Division of Marine Fisheries
February 15, 2022 - *River Herring Network*

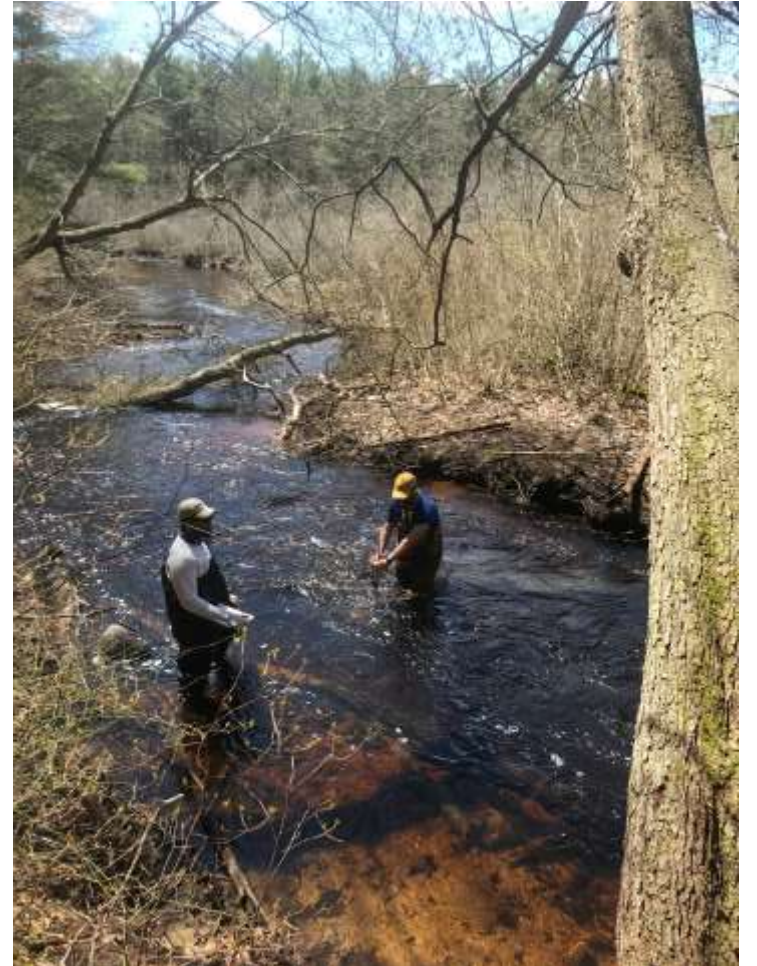
Elm Street Dam Removal, Jones River, Kingston

Dam removed in December 2019

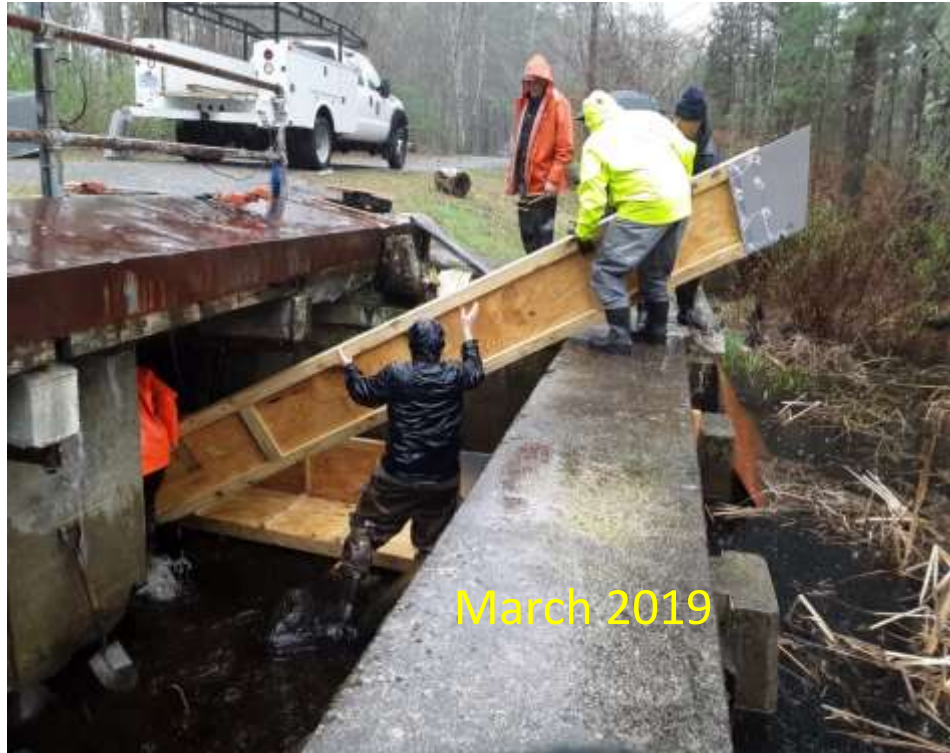
Forge Pond Dam - Jones River, Kingston Fishway and Dredging Design/Permitting

- USFWS Scoping Design for new fishway
- Contract underway for Design/Permitting
- U-Mass Dartmouth MS project on silver eels at Forge Pond Dam

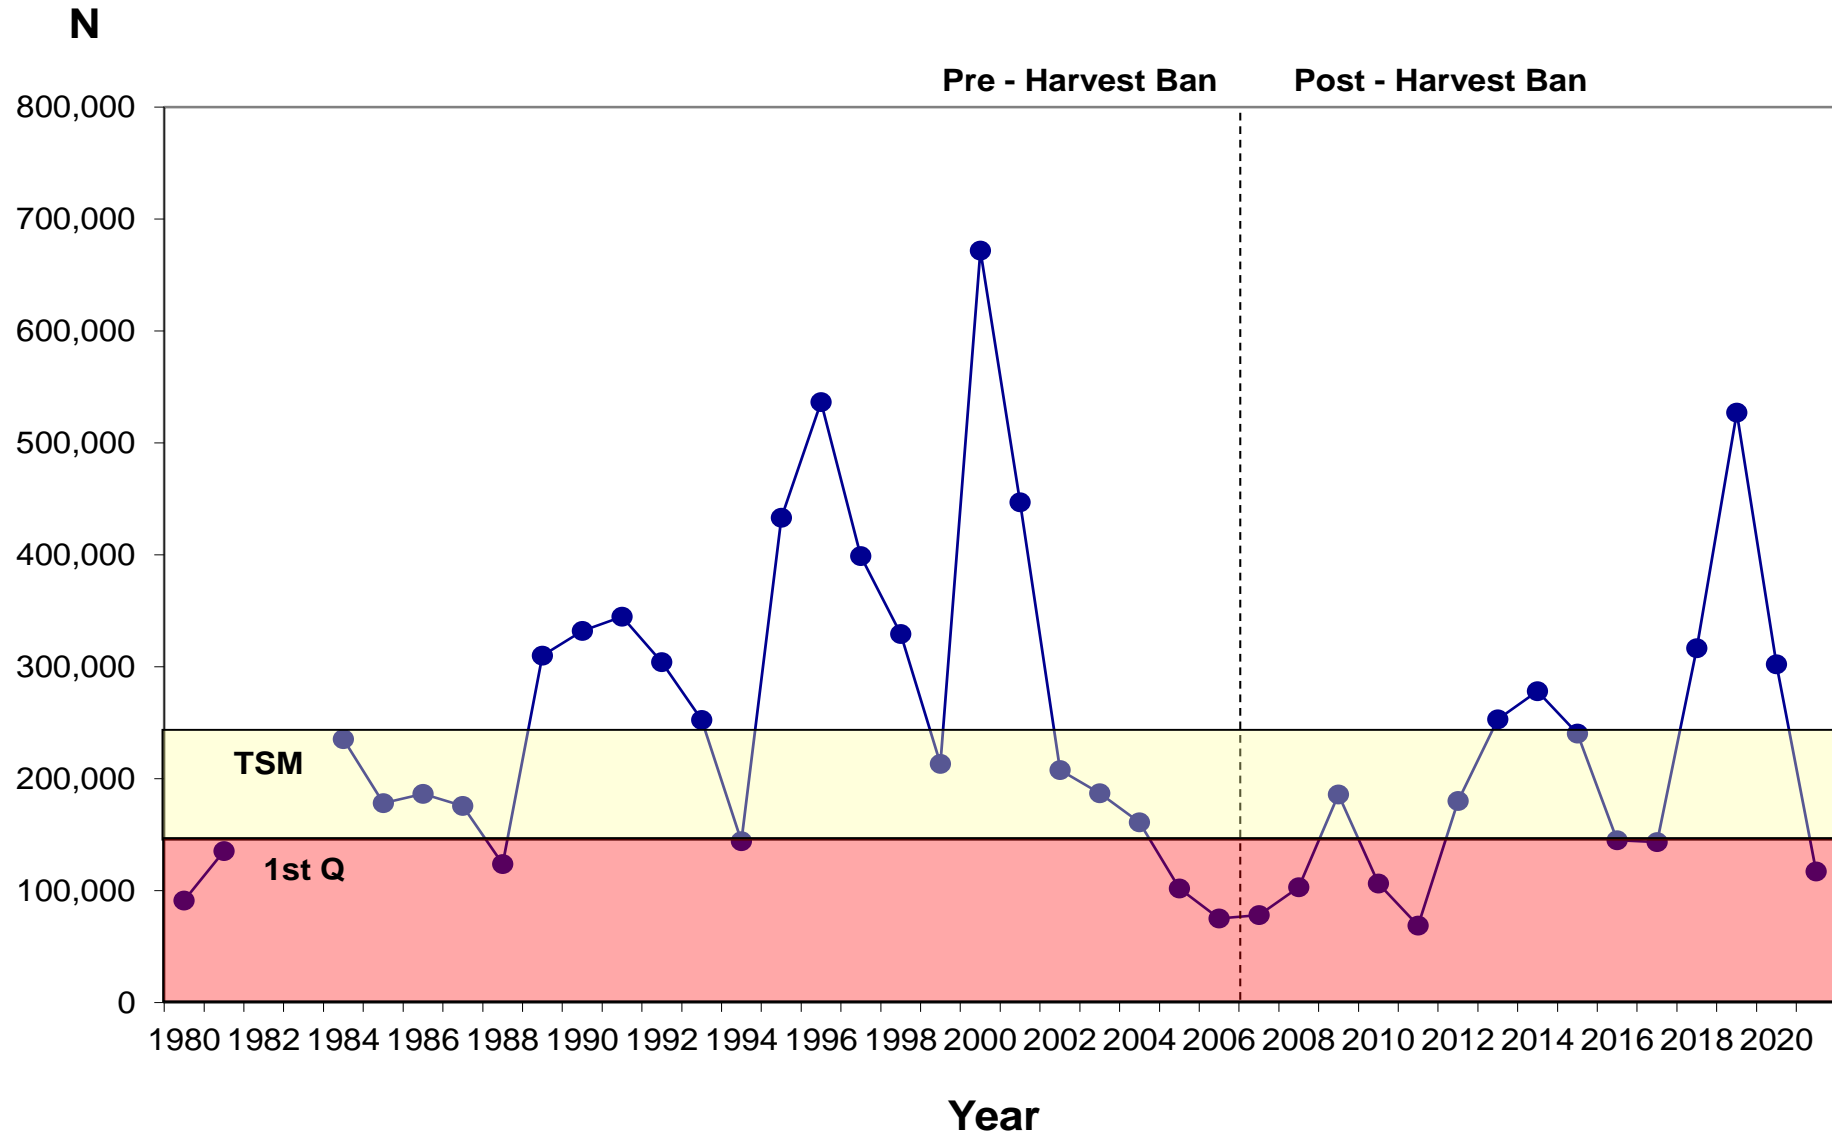
Monument River – Electric Count 1980 - 2021

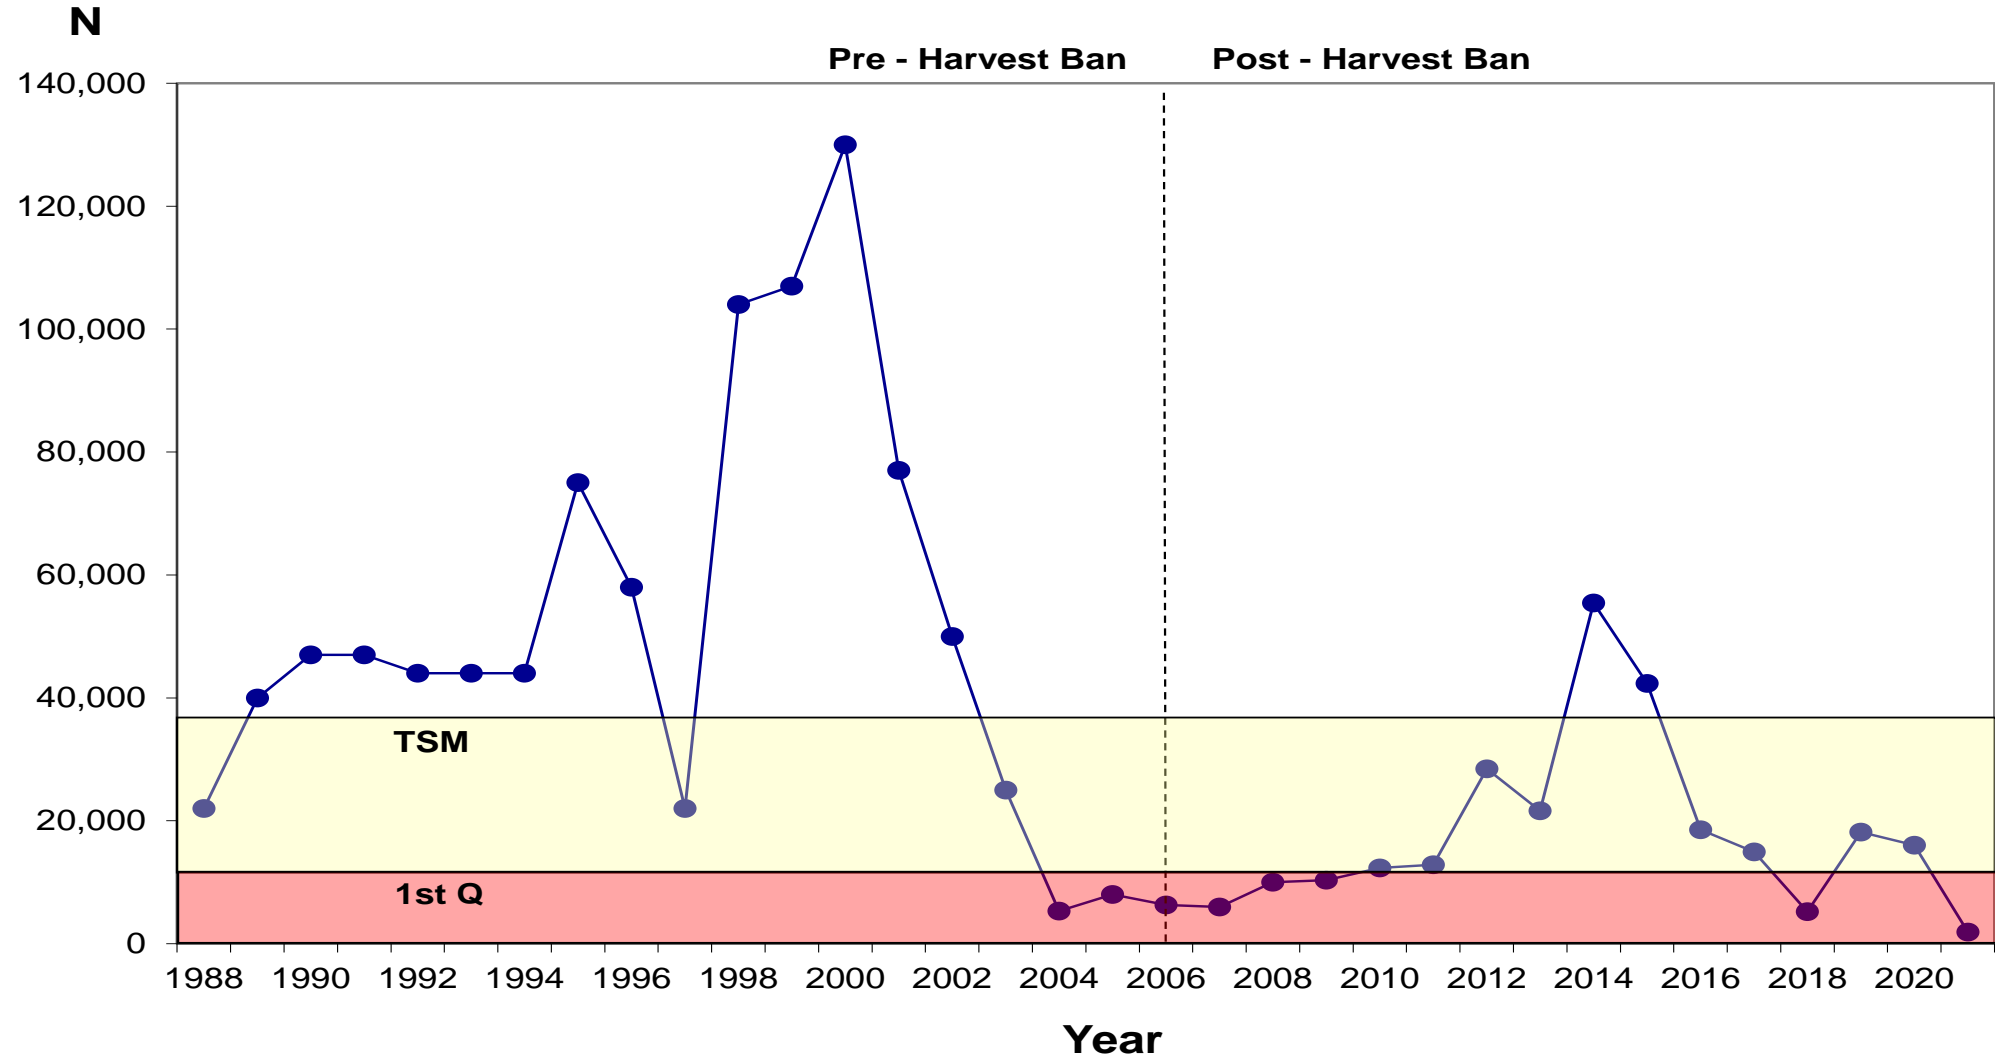
Mattapoisett River – Electronic Count 1988 - 2021

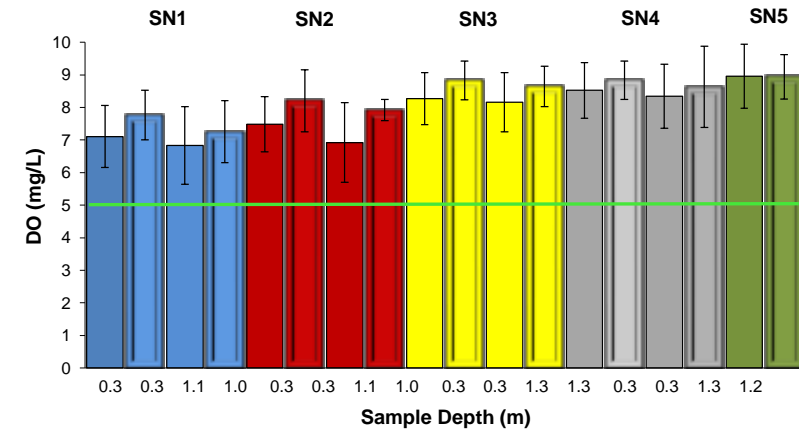
Figure 8. DO (mg/L) measurements taken at Snipatuit Pond, 2013-2014. Station averages are presented (+) for 2013 (blank bars) and 2014 (diagonal stripes). Five samples were made at each depth per year.

Positive conditions for water temperature and DO
